BANK EROSION STUDY

Ohio River Division Field
OHIO RIVER BANK
EROSION STUDY.

OHIO RIVER
BANK EROSION STUDY

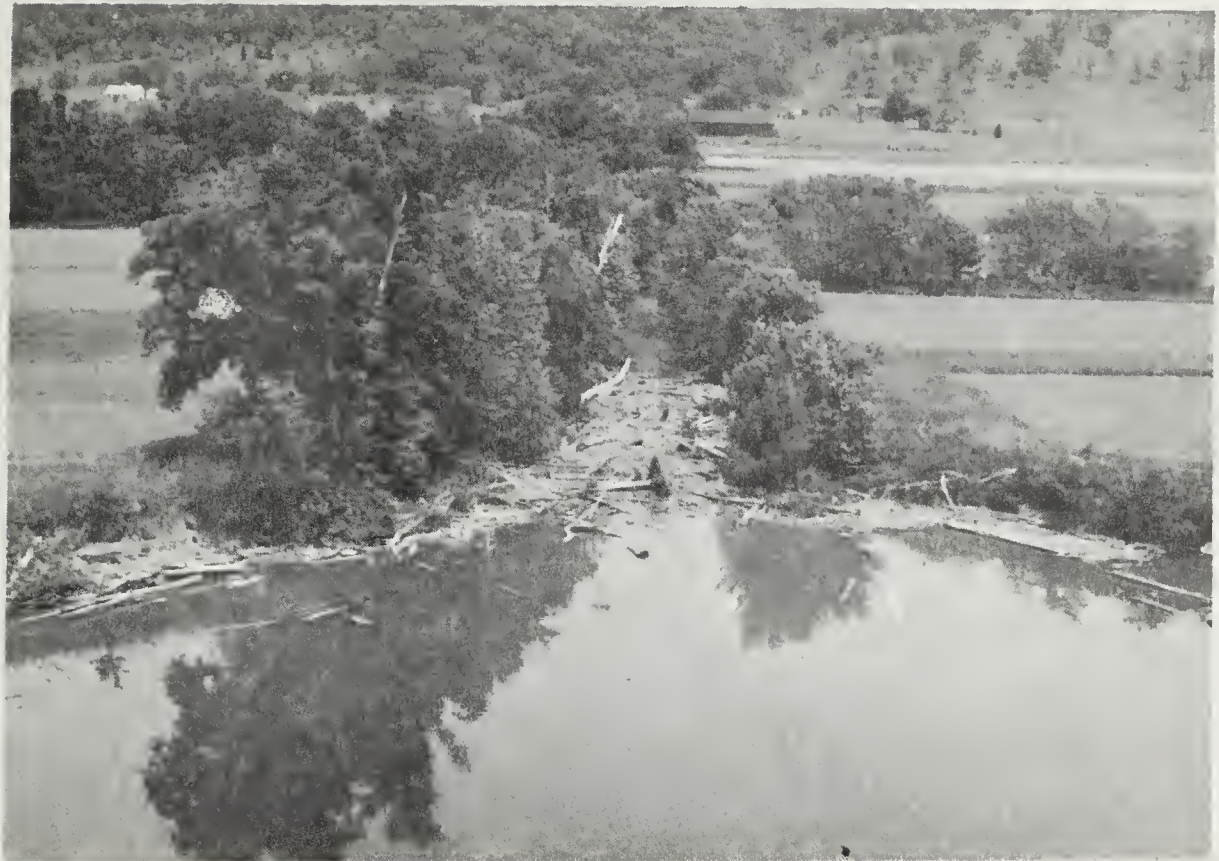
A

Approximate to downstream boundary of tract.
Note drift accumulations. 24 May 1977

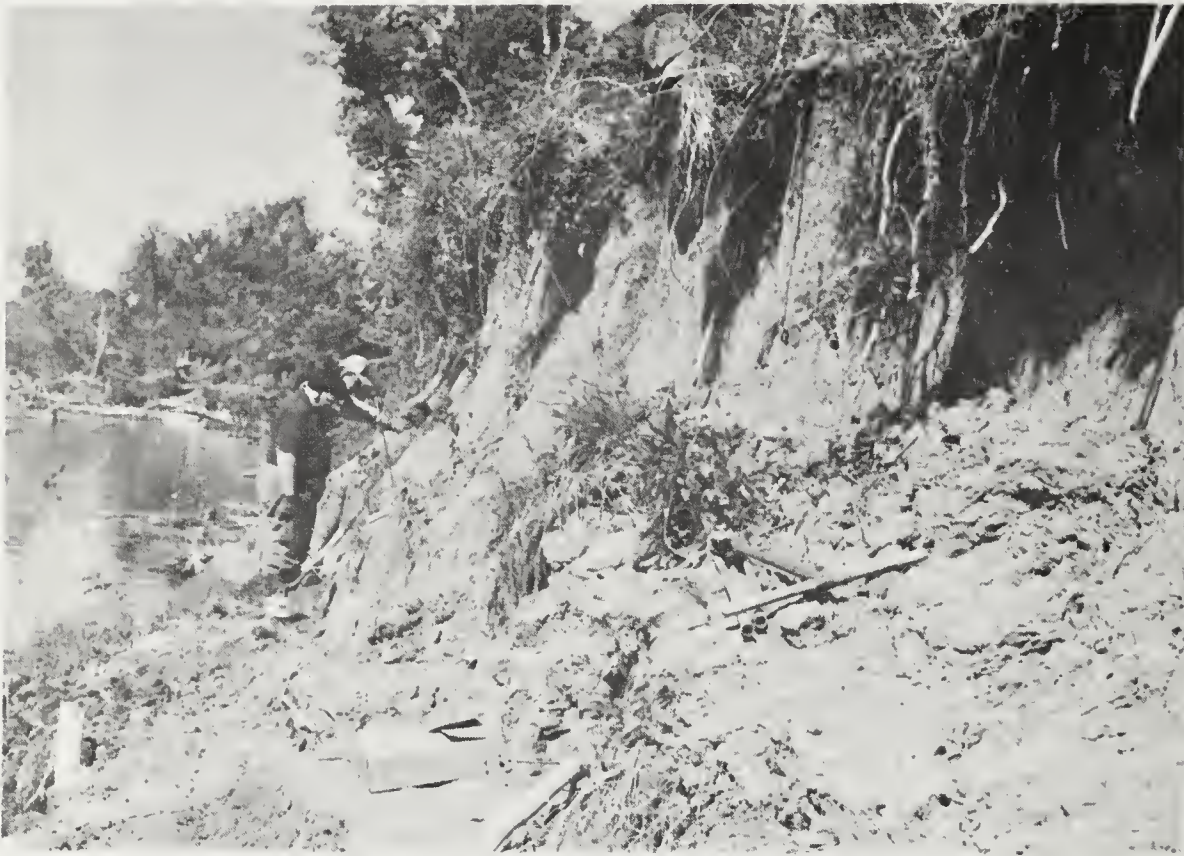
C

Recent erosion at upper bank and benching
within debris at toe 10 May 1977

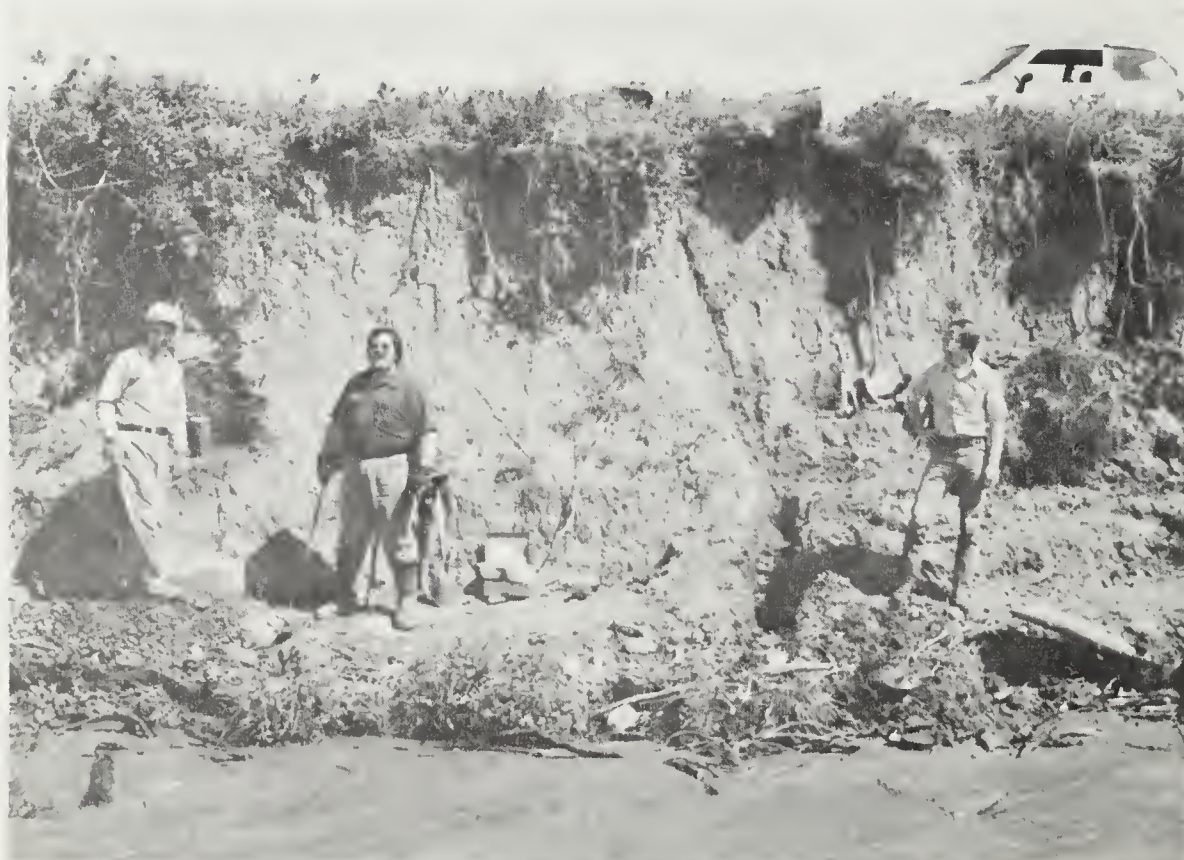
D

Sample site with excavated undisturbed
sample in-situ.

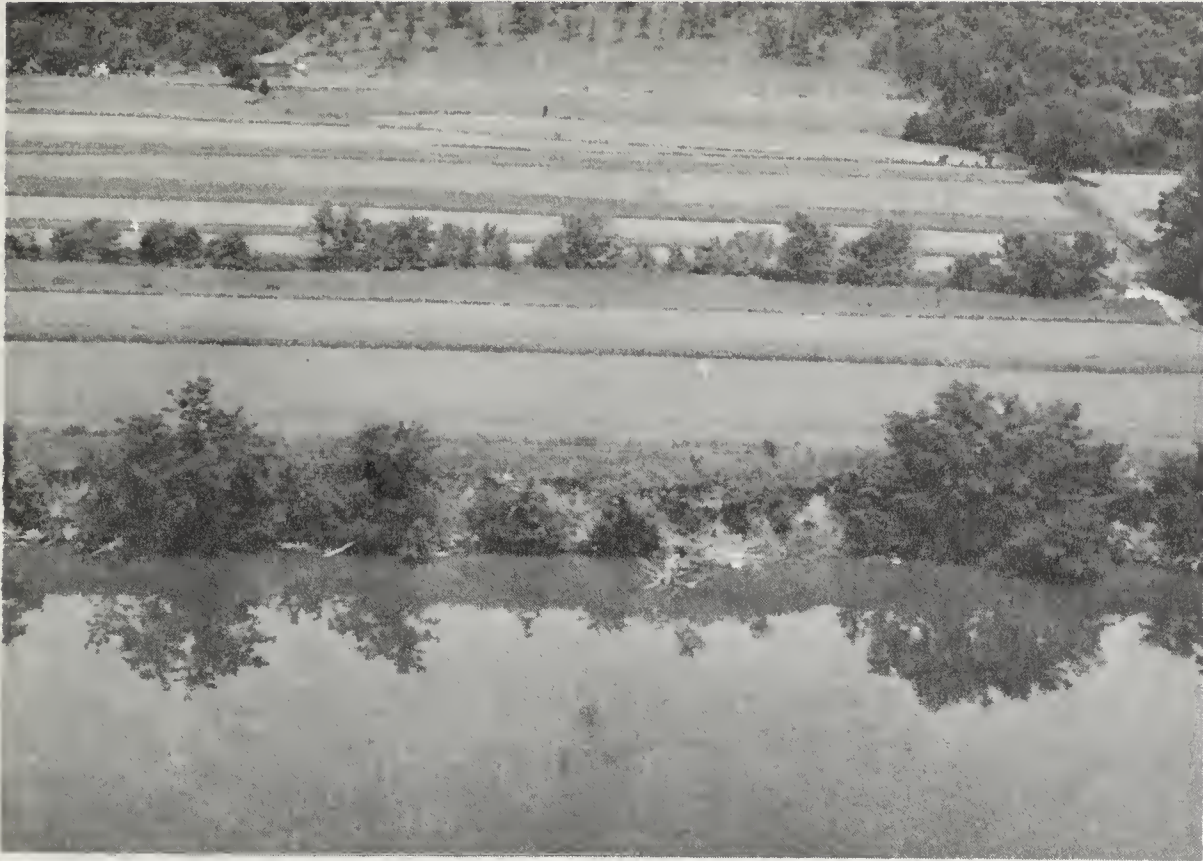
E

Reach of bank approximate to Rice and Poston
tract boundaries. 10 May 1977.

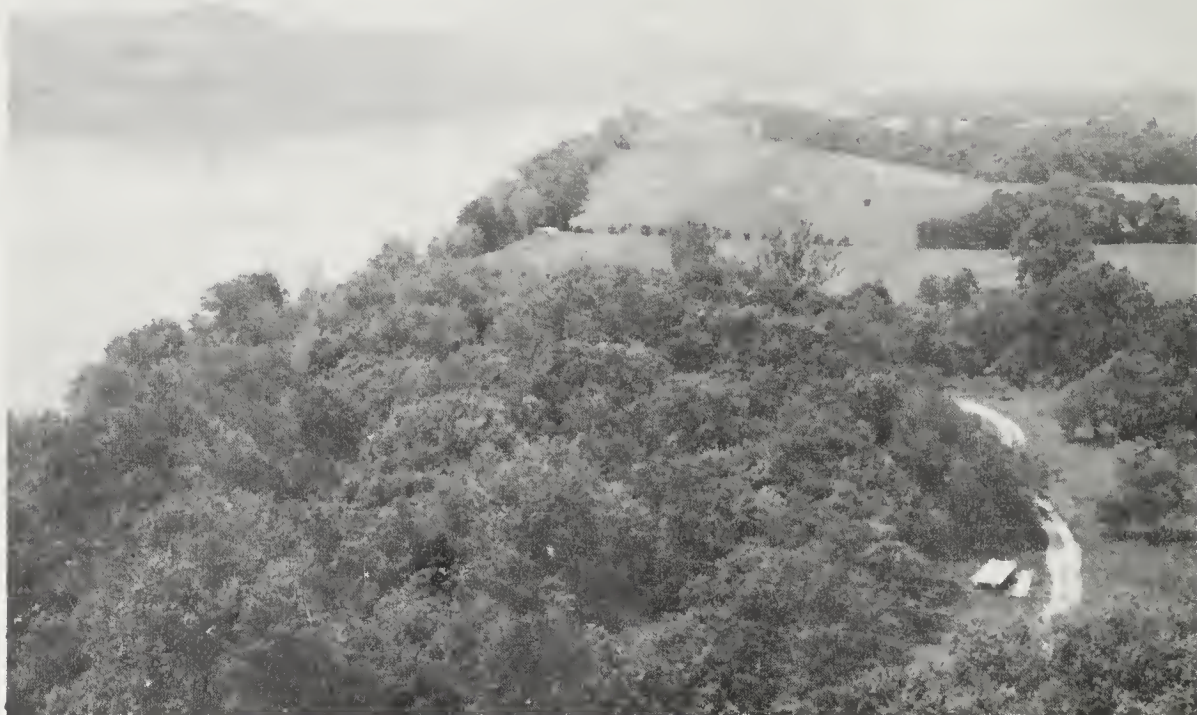
A

Looking downstream at Rice - Poston - Rice
Tracts. 24 May 1977

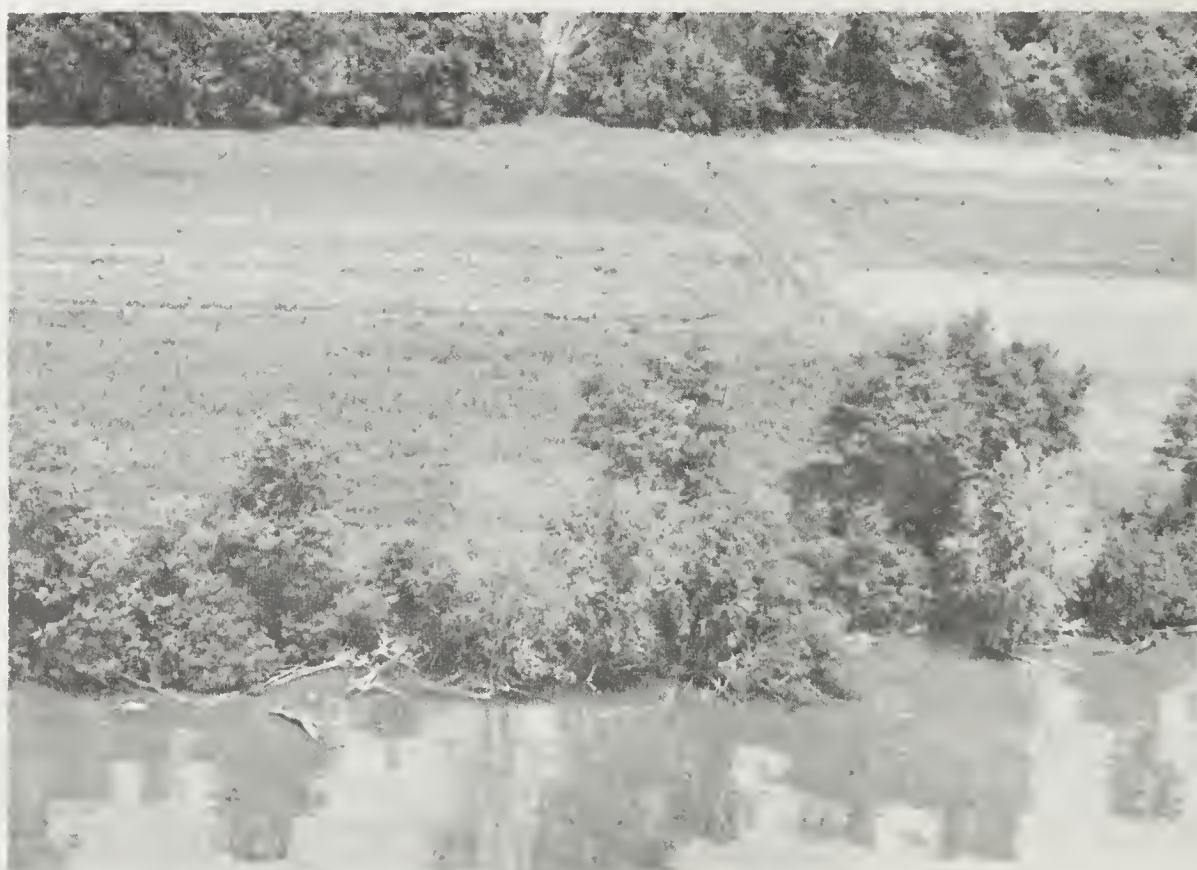
B

Approximate to upstream tract boundary
showing sample site. Note vegetation
in shallows. 24 May 1977

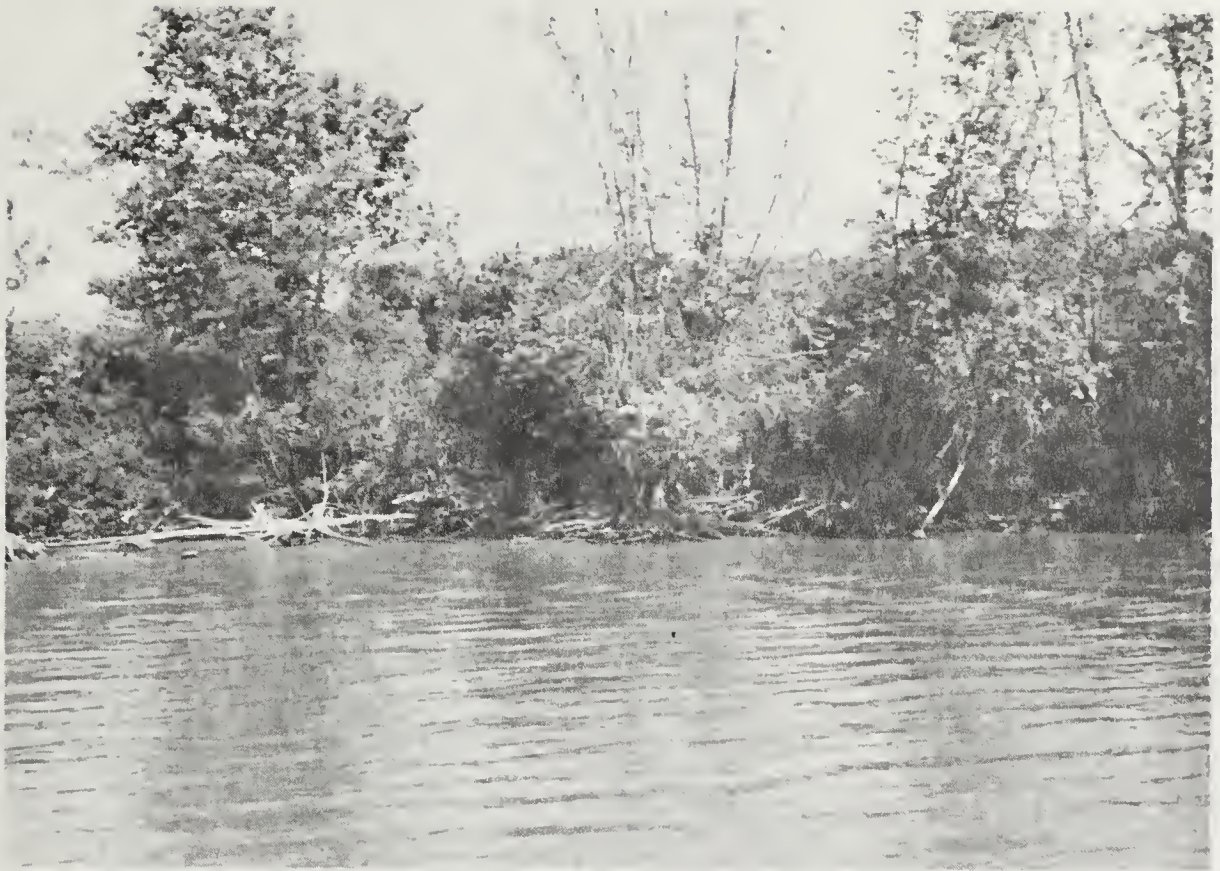
C

Sample site. Note exposed root systems.
10 May 1977

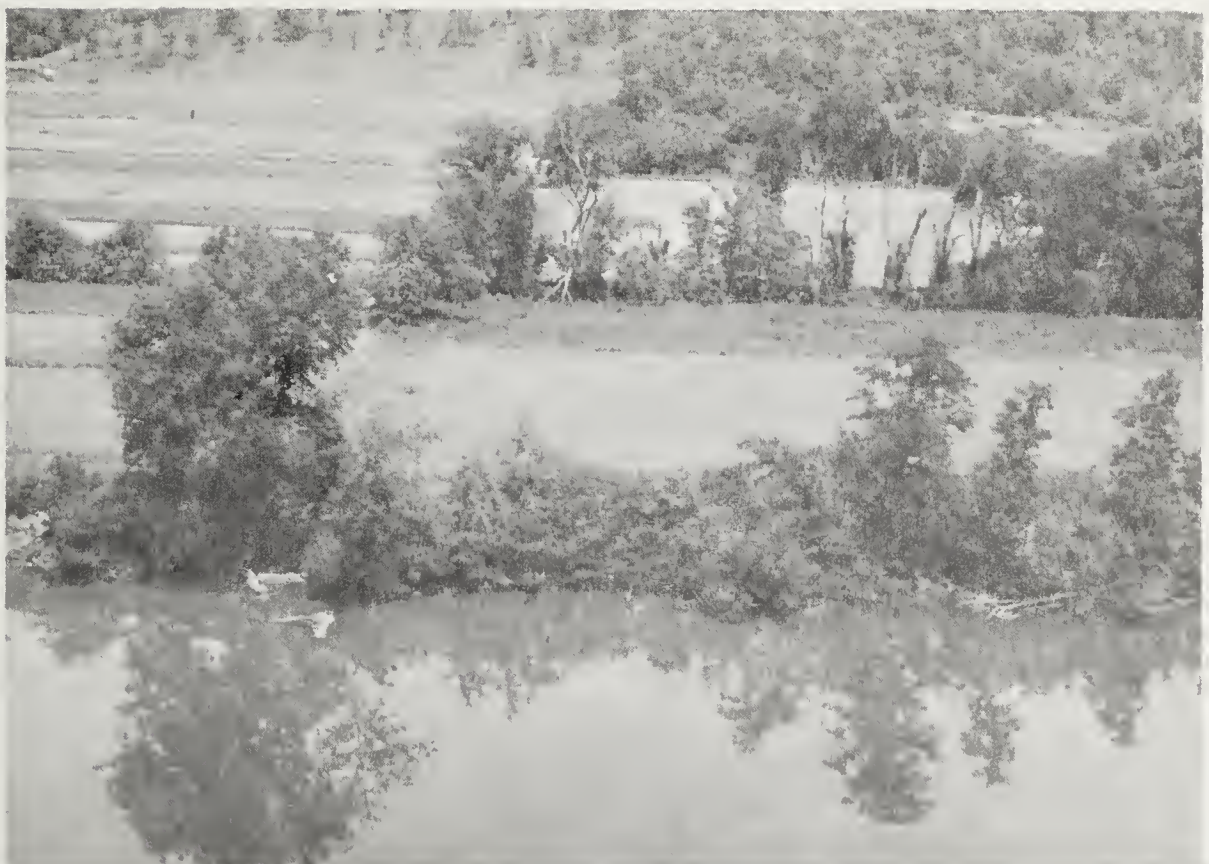
D

Approximate to downstream tract boundary.
Note aquatic vegetation in shallows.
24 May 1977

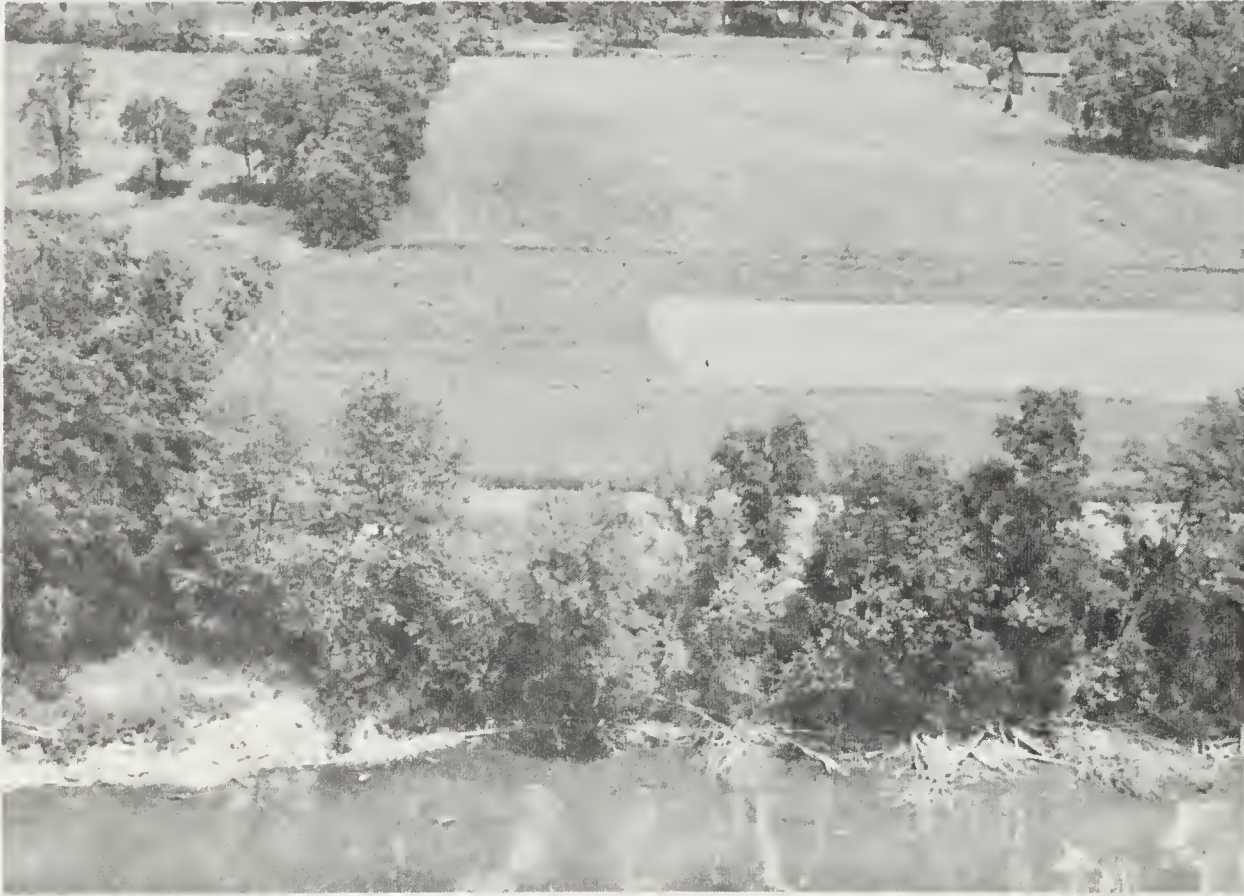
A

Approximate to downstream tract boundary.
Note fill and dumped rock.
24 May 1977

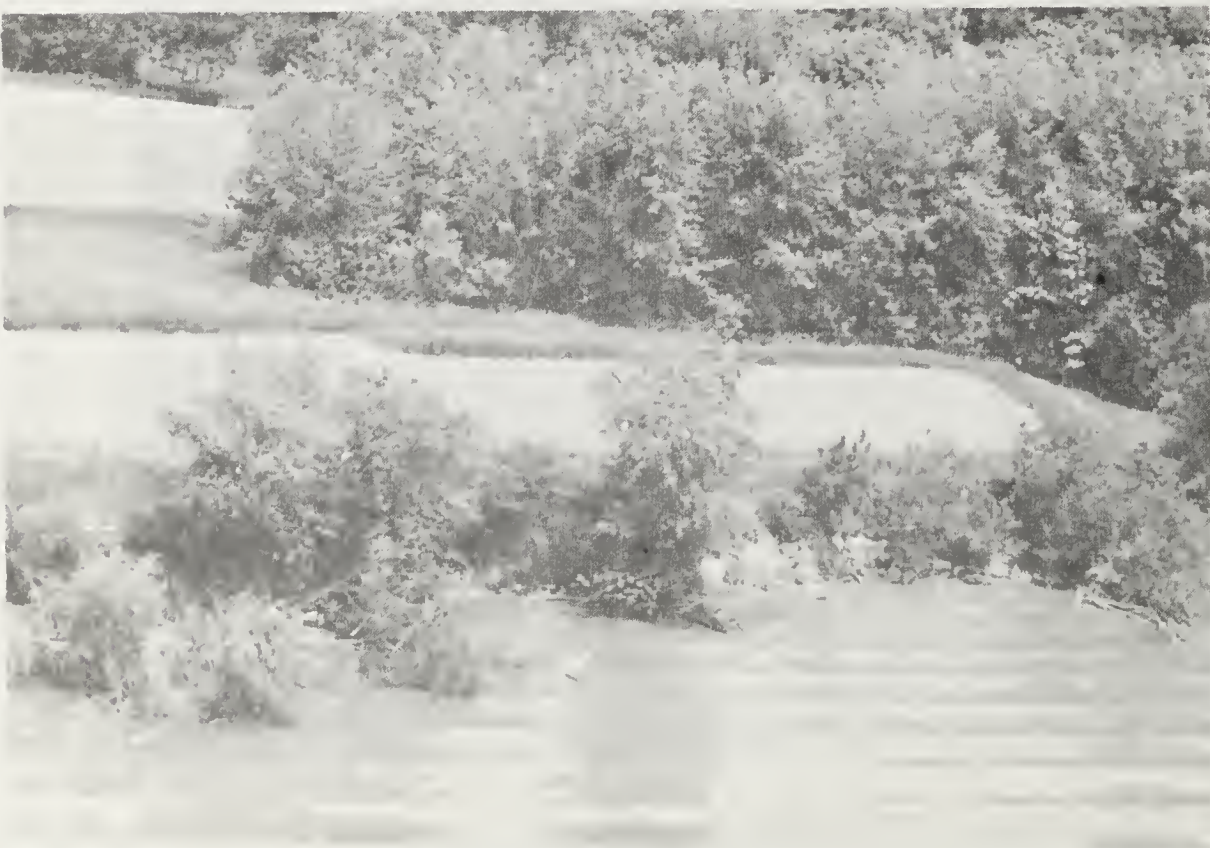
B

Approximate to upstream tract boundary showing erosion
scarps and sample site. 24 May 1977

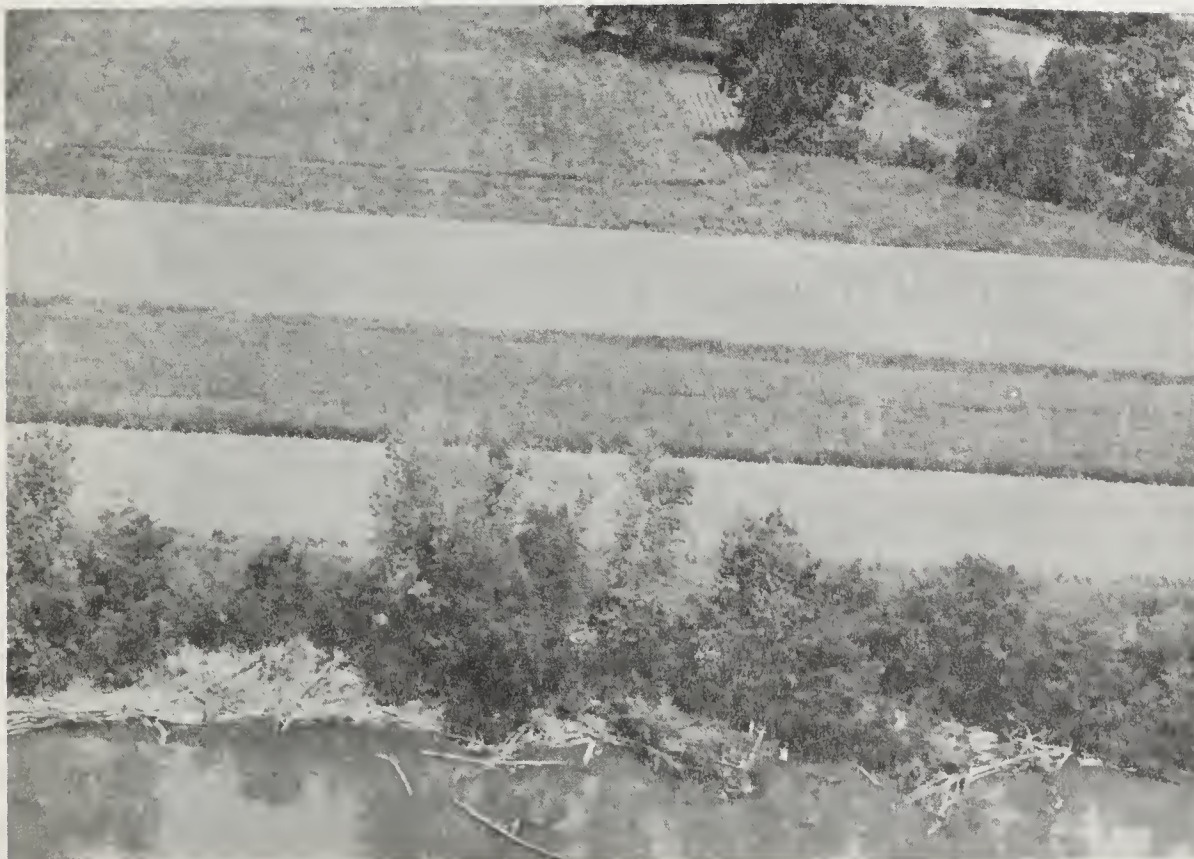
D

Mid-tract reach of bank showing erosion scarps and
drift accumulations. 24 May 1977

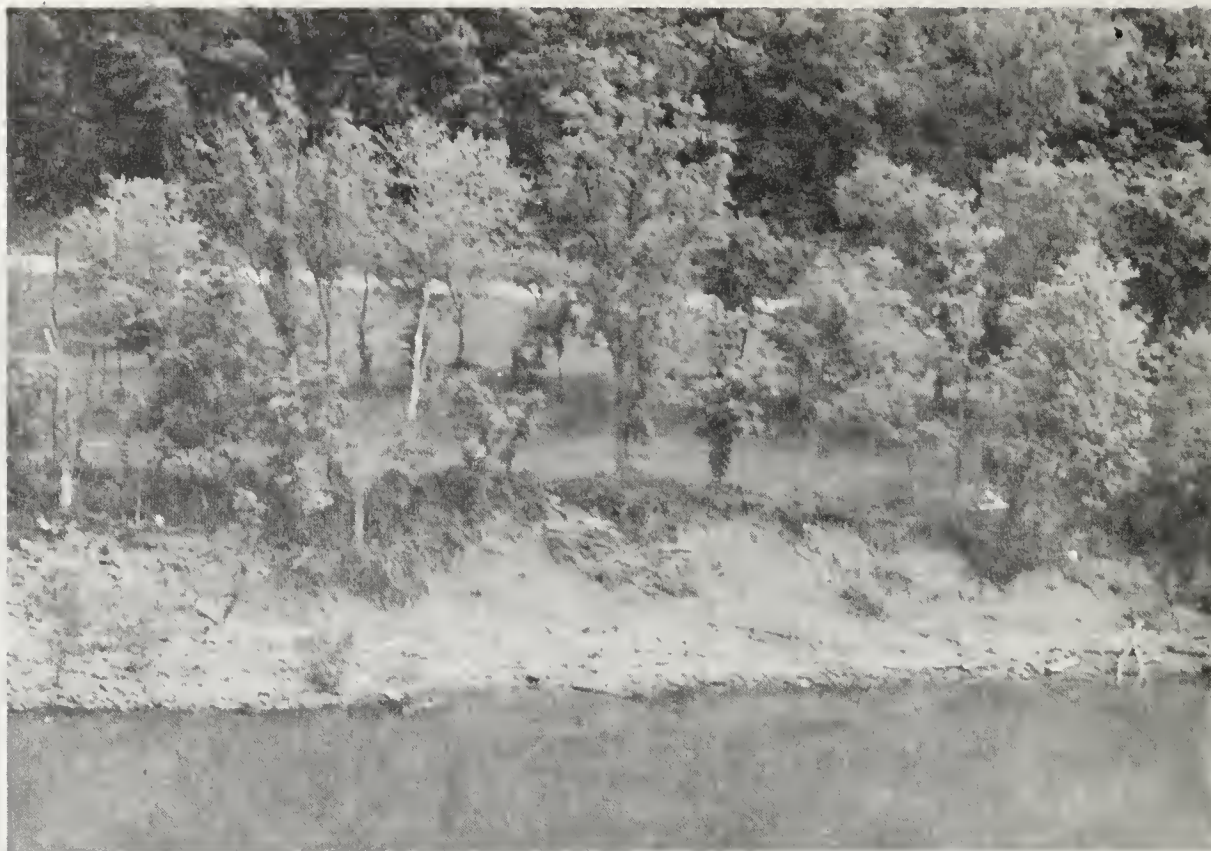
A

Bank at sample site. Note colluvial
debris. 24 May 1977

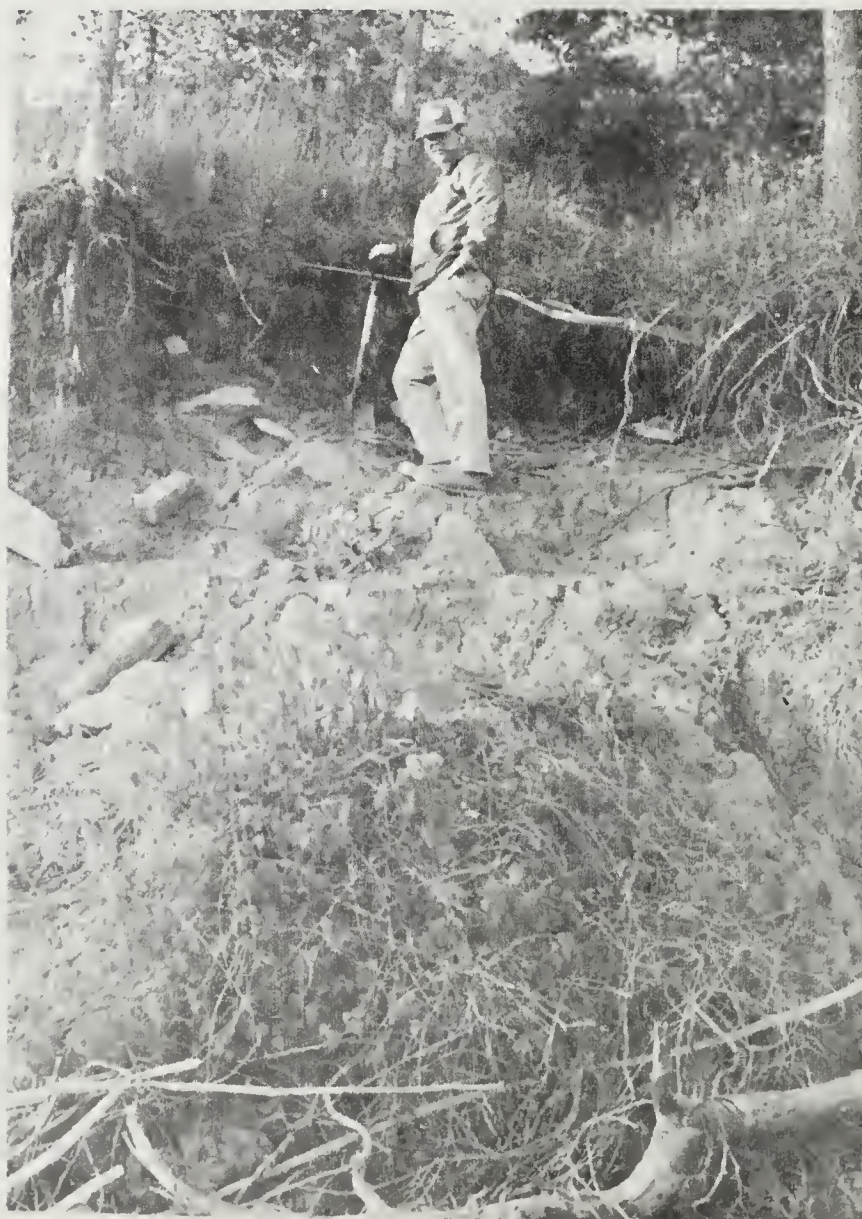
B

Sample site showing colluvium.
10 May 1977

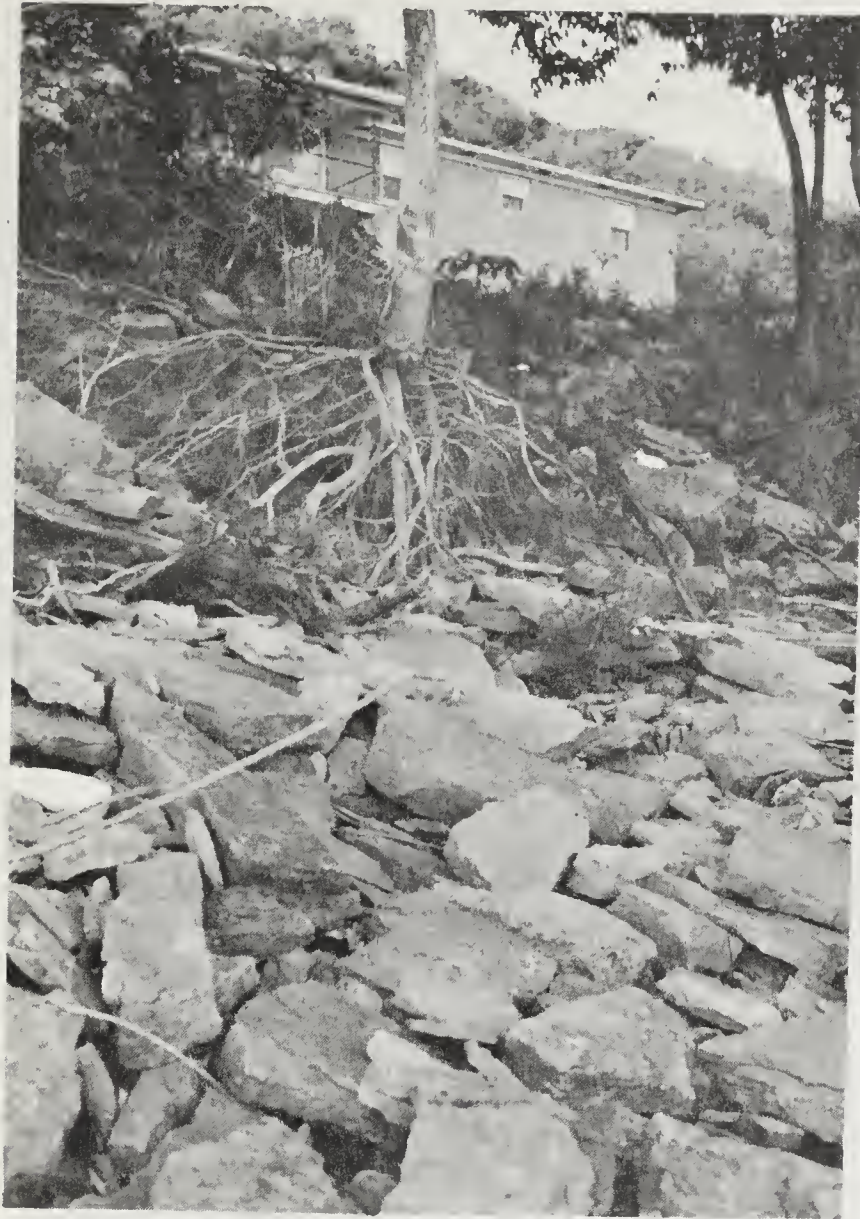
C

Dumped stone with colluvium derived
rock debris. 10 May 1977

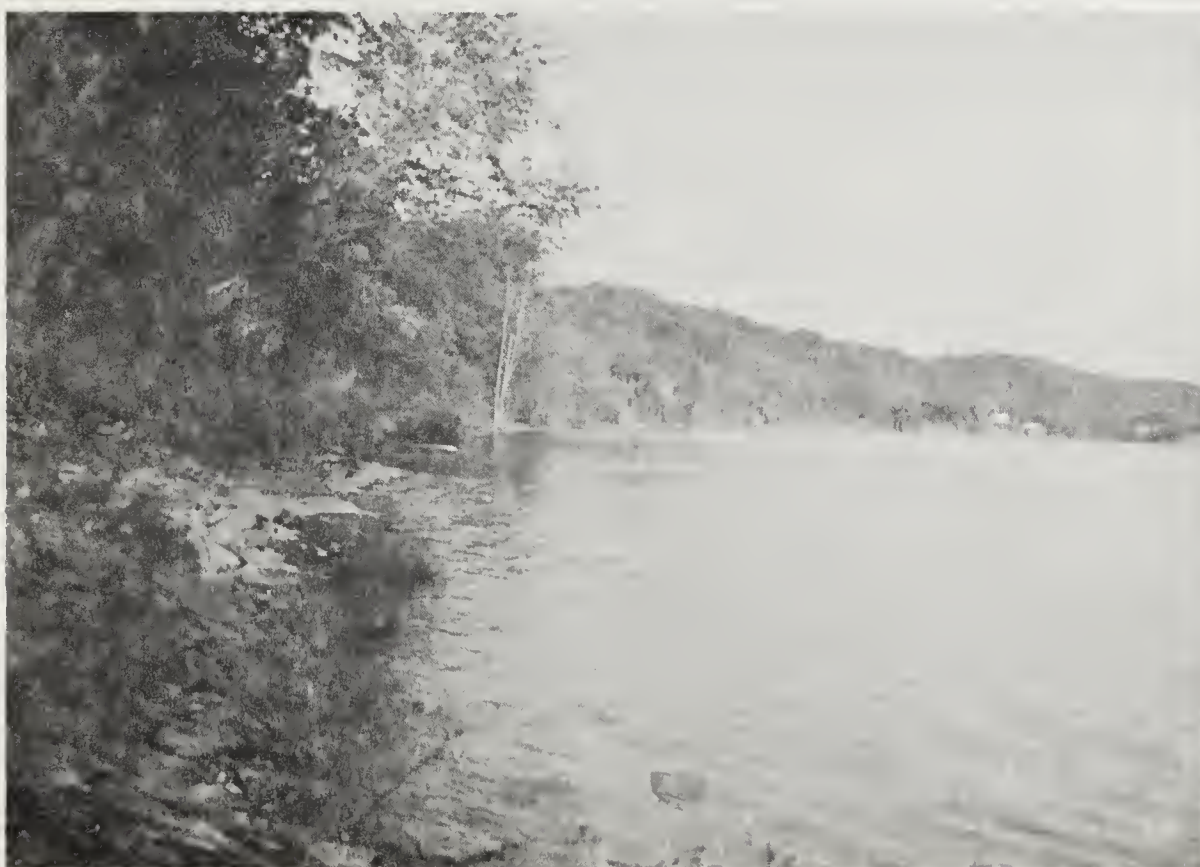
D

Reach of bank looking upstream from Wood
tract. 10 May 1977

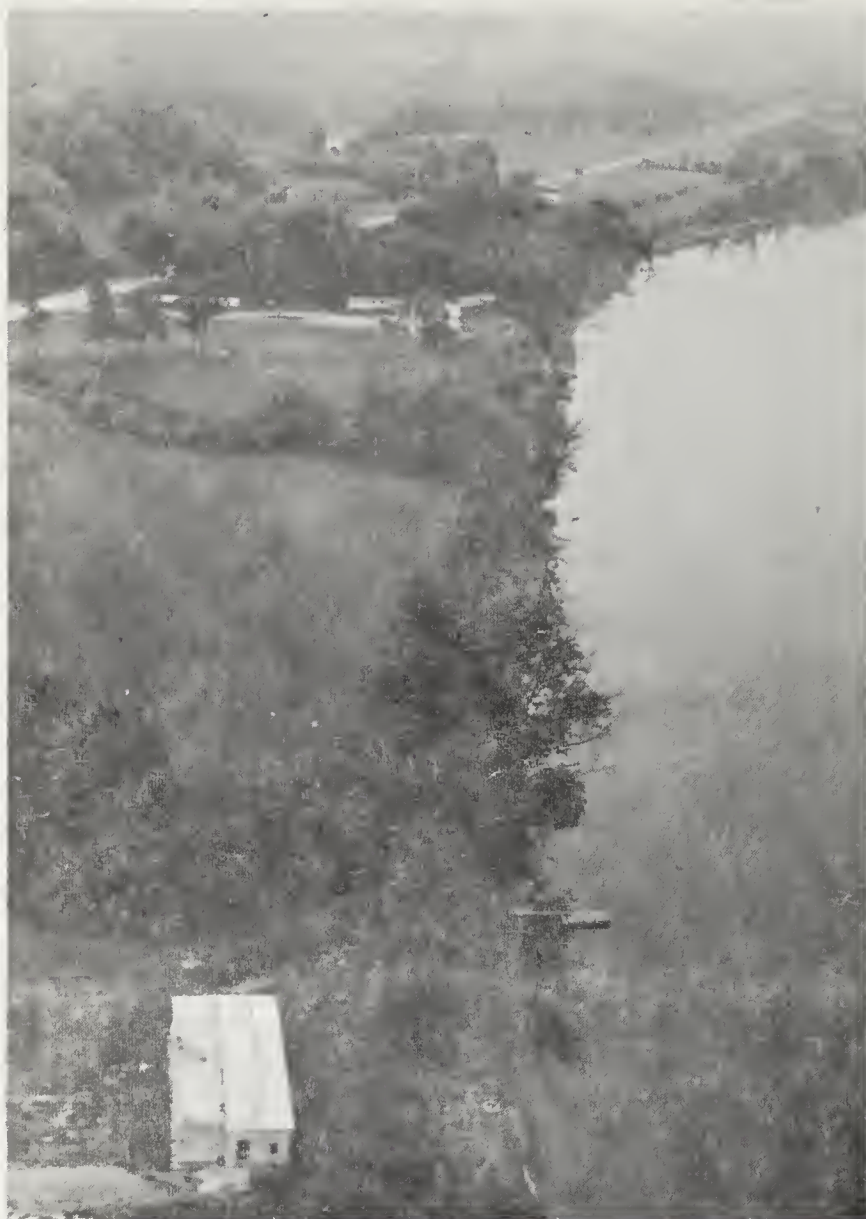
A

Reach of bank looking upstream from
McNelly tract at Chouinard and Schwab
Tracts. 24 May 1977

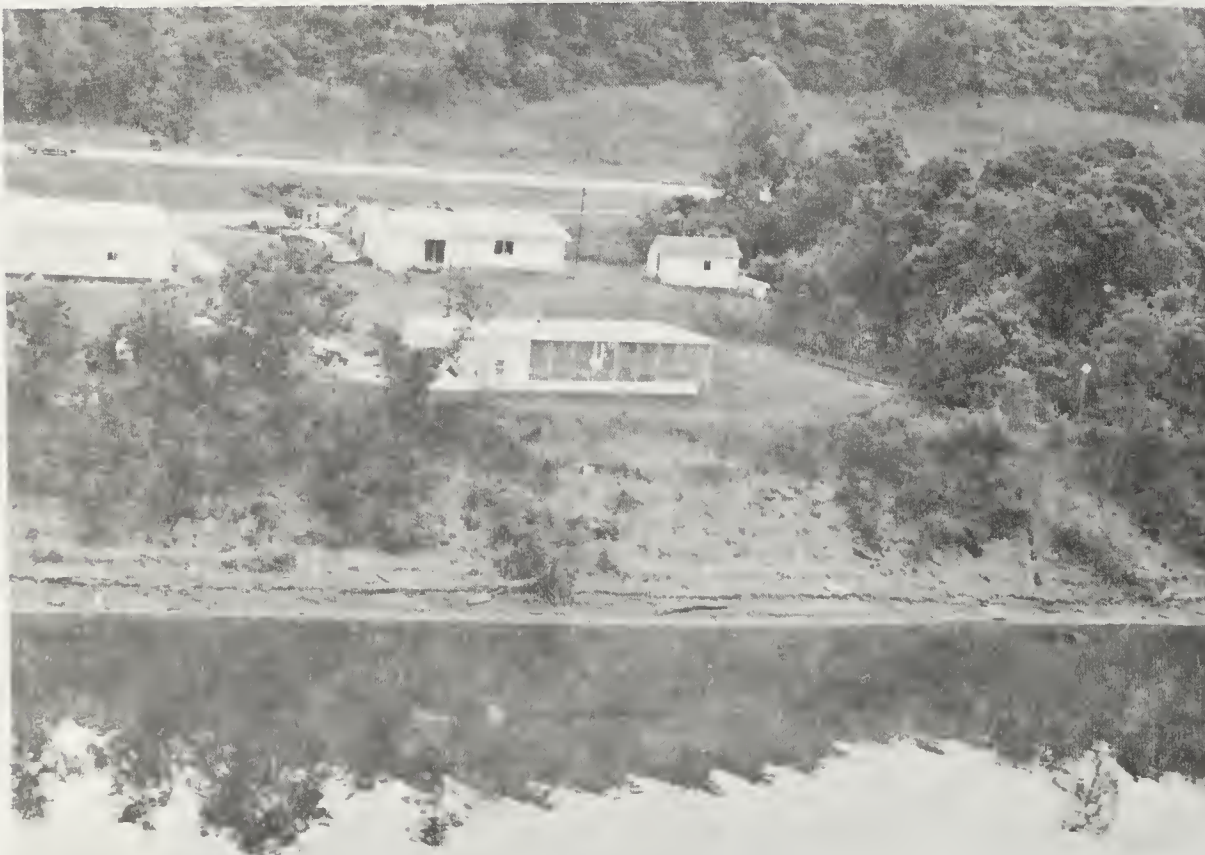
B

Recent slumpage scarps in bank at sample
site. 24 May 1977

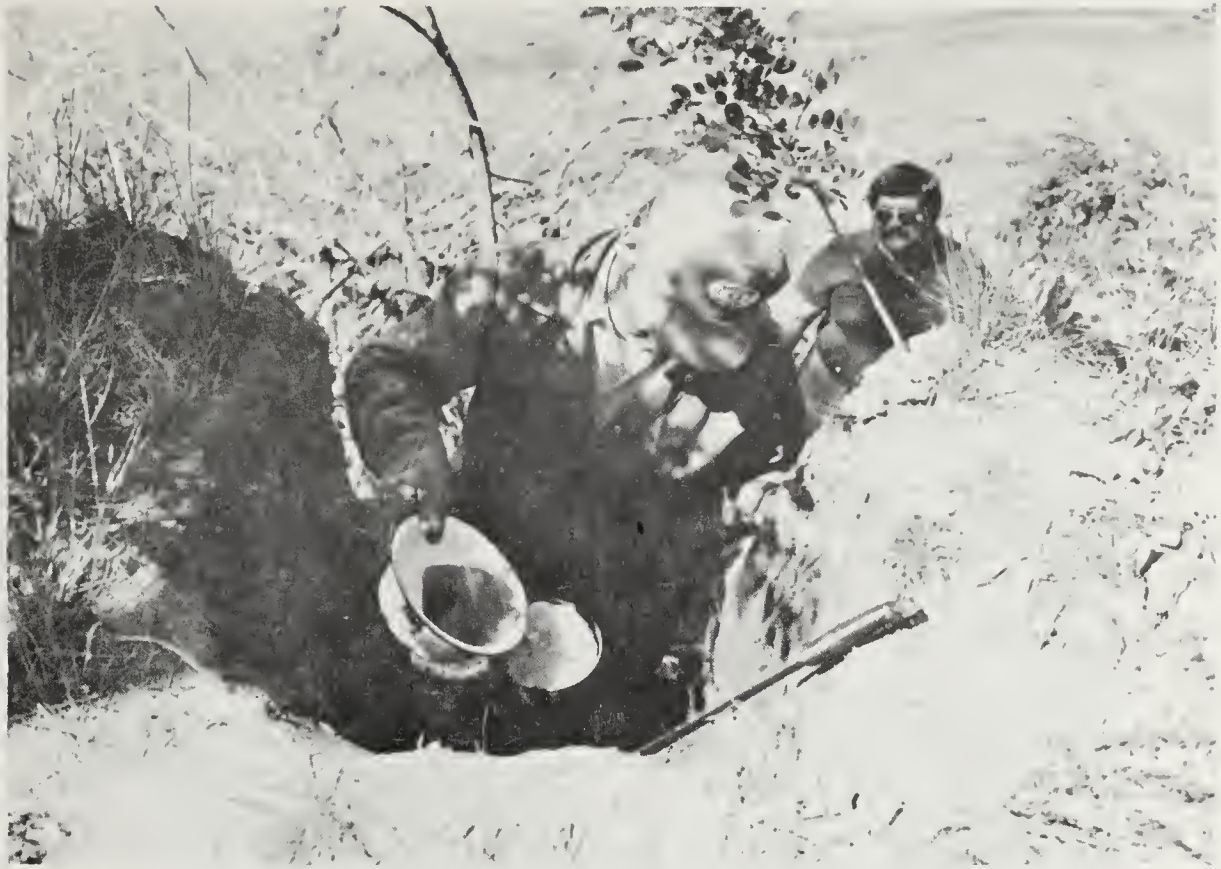
C

Preparation of undisturbed sample in-situ at
sample site. 11 May 1977

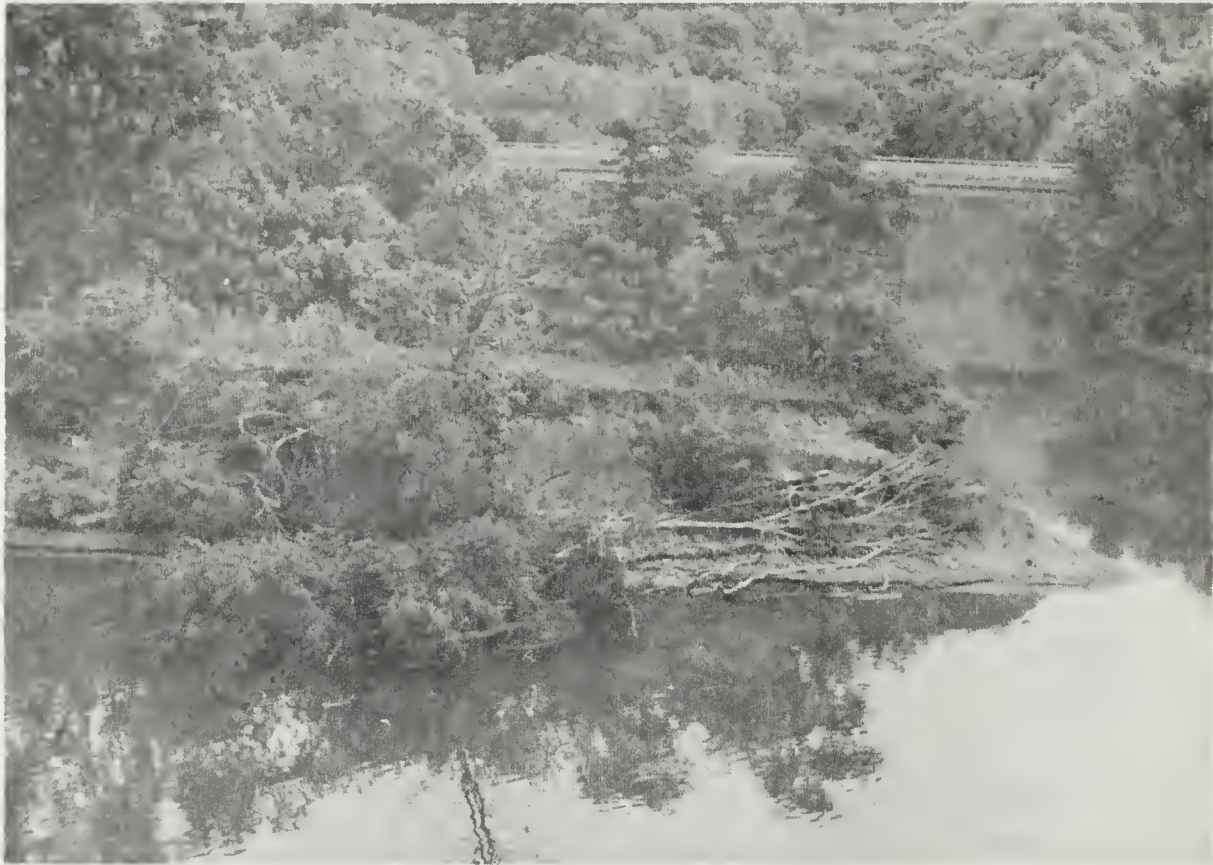
A

Upstream area of tract and at sample site approximate
to confluence Ohio River and Three Mile Creek.
24 May 1977

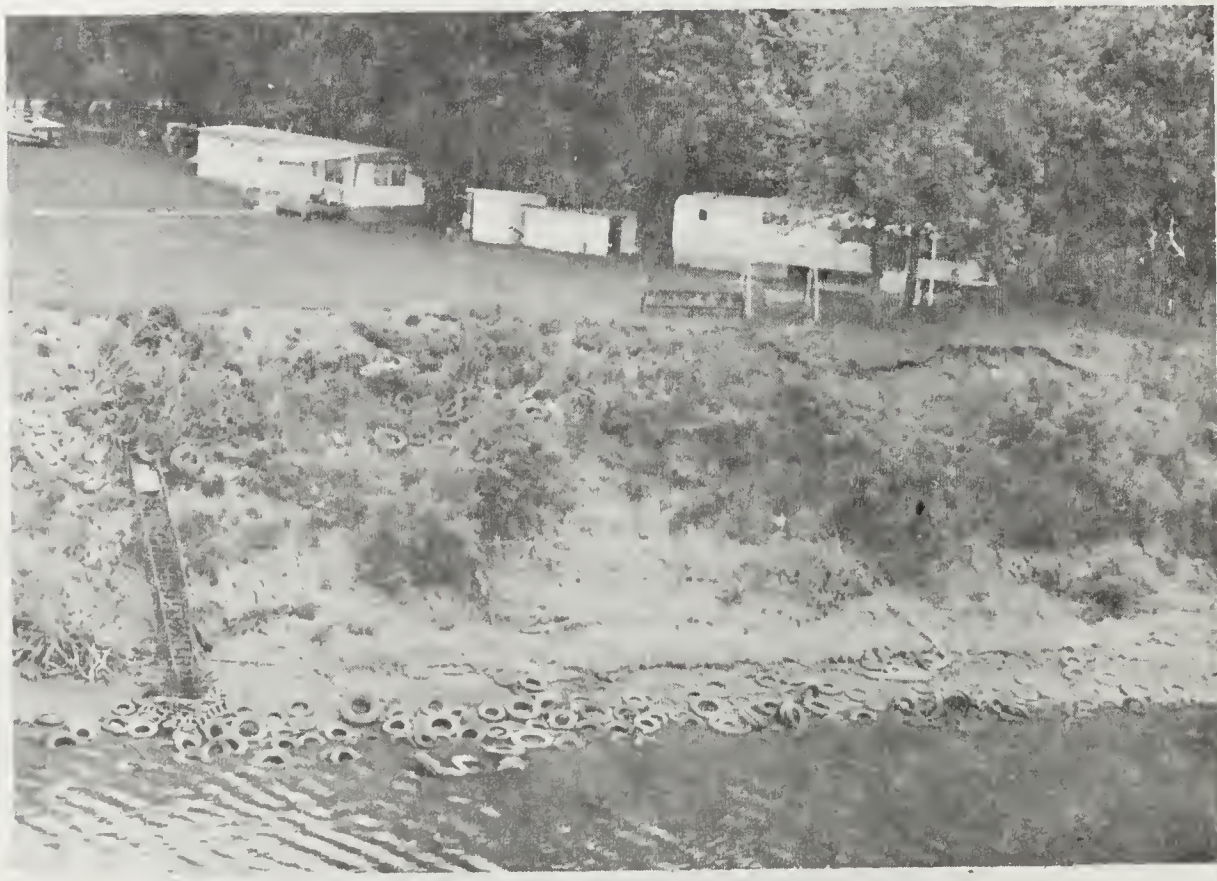
B

Reach of bank approximate to structures and sample
site. Note recent slumpage scarps at top of bank.
24 May 1977.

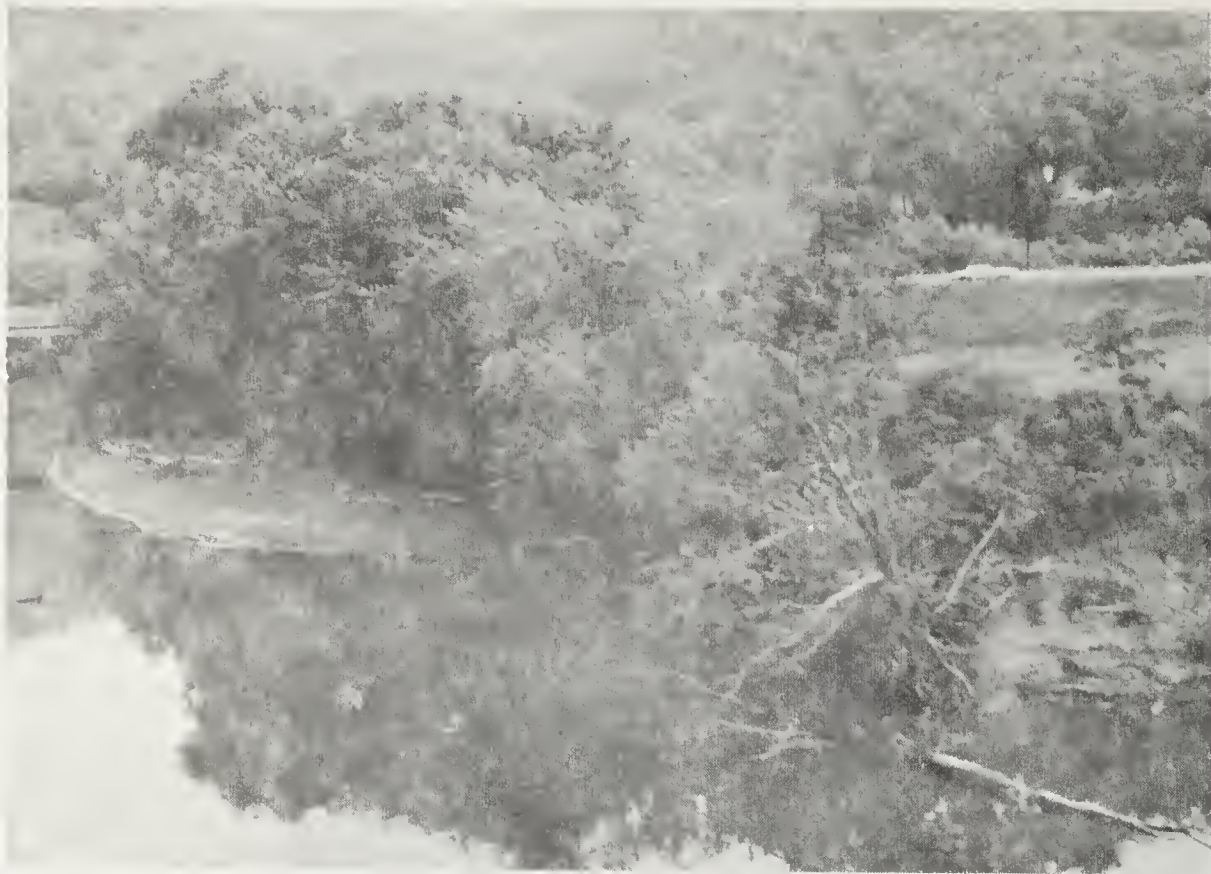
A

Upstream area of tract approximate to the confluence of Ohio River and Three Mile Creek. 24 May 1977

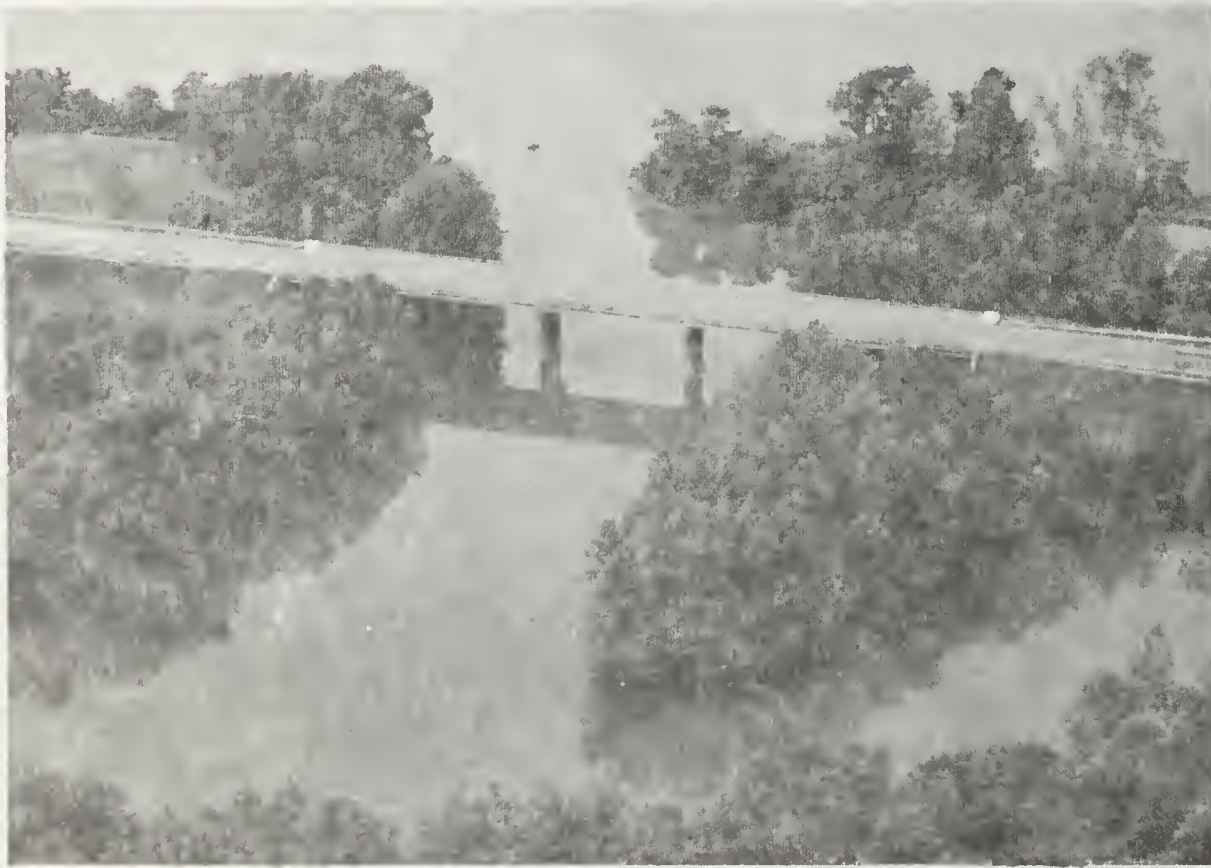
B

Three Mile Creek showing adjacent Schwab and Chouinald tracts. 24 May 1977
